Re: Williams vs D&D Express

The following report summarizes my investigation into and analysis of the 24 April 2016 motor vehicle crash involving a 1995 Buick Roadmaster and 2008 Freightliner Cascadia. The 1995 Buick Roadmaster was being operated at the time of the accident by Mr. Daryl Williams. Mr. Lamario Henderson, Larry Henderson, and Jametrius McCon were riding as Mr. Williams' passengers at the time of the crash. The 2008 Freightliner was being operated by Mr. Adolfo Perez at the time of the crash. Mr. Carlos Laguna was riding as Mr. Perez's passenger at the time of the crash.

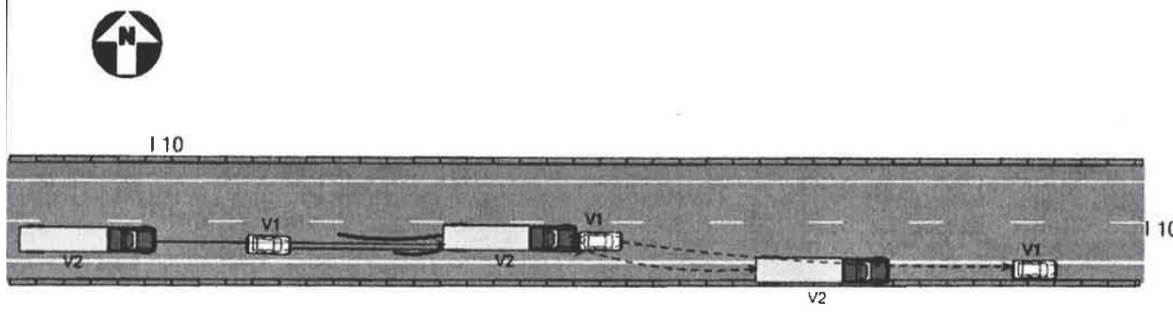
Figure 1: Diagram from Mississippi Uniform Crash Report

According to the crash report, the 1995 Buick was traveling in the right, outside lane. Mr. Williams indicated he ran out of gas and the vehicle came to an abrupt stop. The 2008 Freightliner was also traveling in the right, outside lane.

The collision occurred when Mr. Perez's 2008 Freightliner overtook Mr. Williams much slower-moving 1995 Buick and struck the rear offset slightly to the driver's side. After impact, both vehicles came to final rest in the eastbound emergency shoulder, facing east.

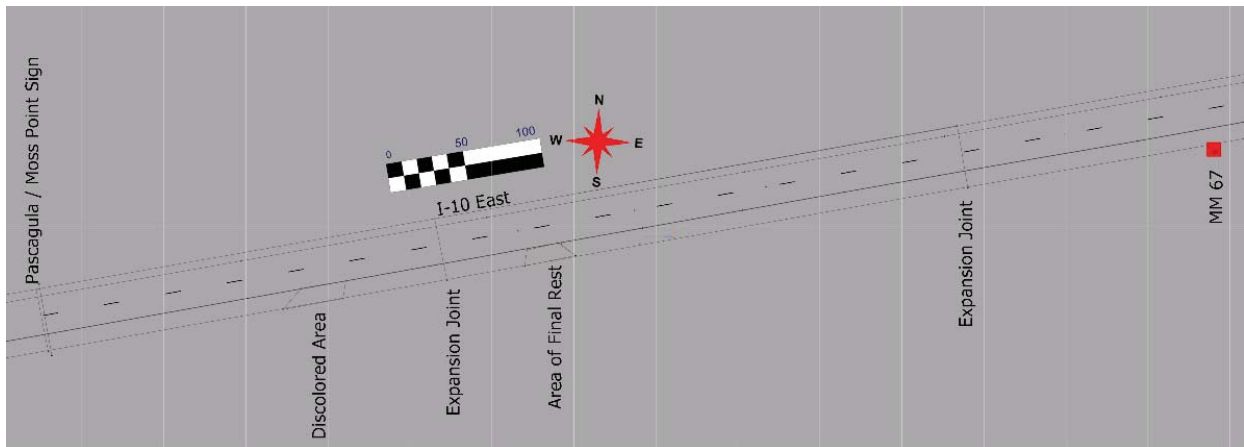
Figure 2: Diagram showing potential 2008 Freightliner final rest.

The location of final rest for the 2008 Freightliner was located using GPS coordinates and matching roadway markings found in trooper photographs with physical markings seen at the crash site.

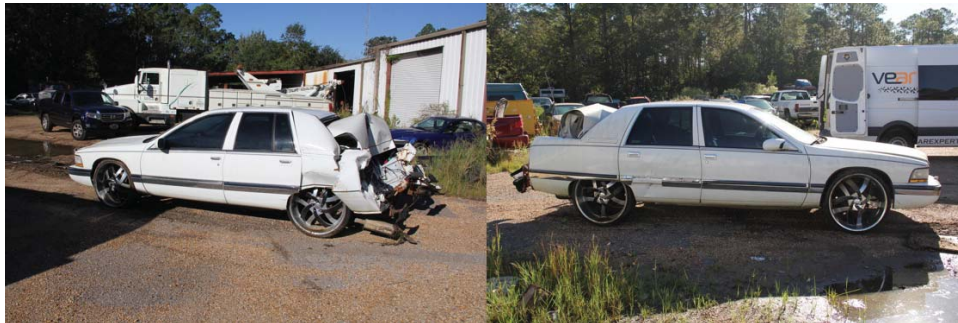
Photograph: 1995 Buick Roadmaster

On 17 October 2017, the 1995 Buick Roadmaster was inspected and photographed along with a lamp examination with Mr. Gary Johnson. It is a 4 door sedan with VIN 1G4BN52P2SR405417 and Mississippi license plate JHC689. The vehicle did not have any repairs completed between the time of the accident and time of inspection.

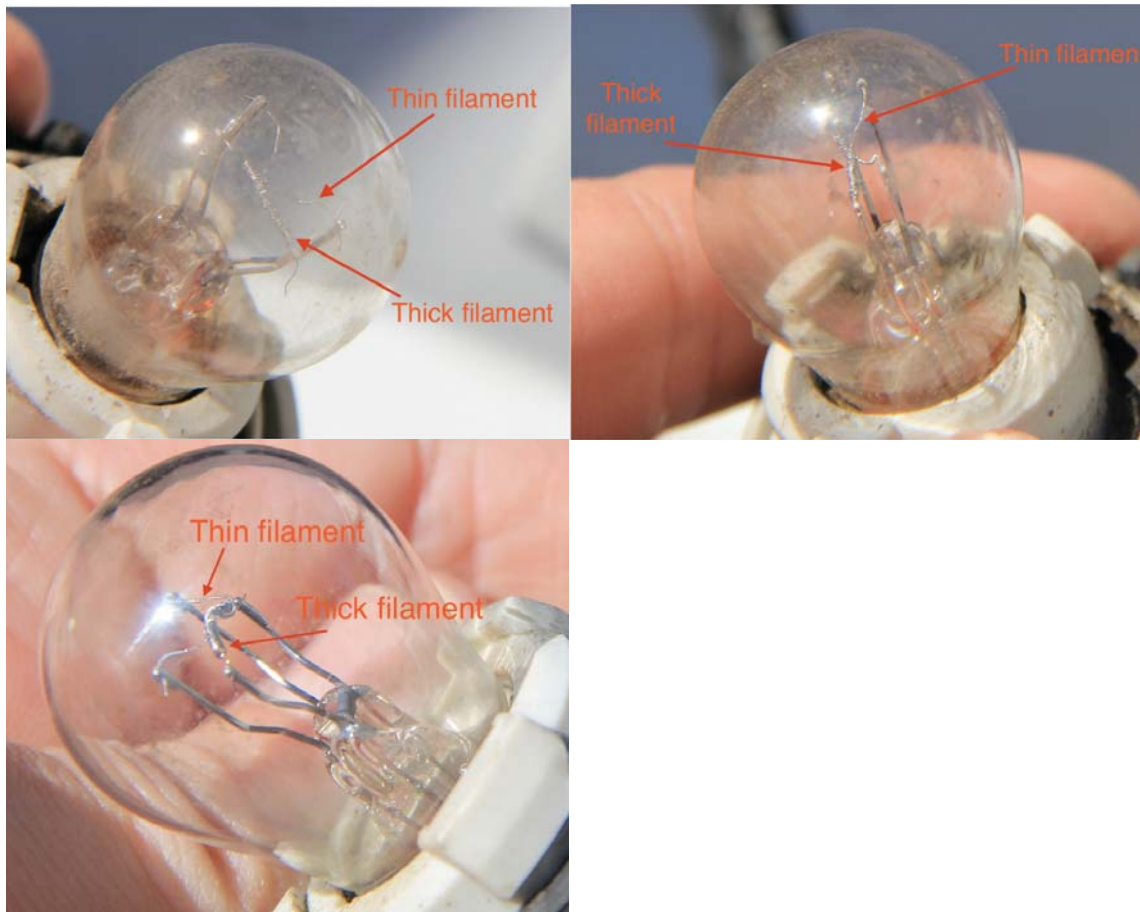
Excerpts: Taillight bulb inspection

The single filament bulbs that were inspected showed signs of "hot shock", which indicates the filament was incandescent or illuminated at the time of impact and the tail lights were on.

The dual filament bulbs that were inspected contain a thin wire and thick wire. The thin wire has a higher resistance to draw less current and give off less light, this wire is typically used for parking and tail lights. The thin wire filaments inspected did show signs of "hot shock" which again indicate they were incandescent at the time of impact and the tail lights were on. The thick

wire has a lower resistance to draw more current and give off more light, this wire is typically used for turn signals, brake lights, and hazard lights. The thick wire filaments inspected did not show the same clear indication of “hot shock”, instead they showed signs of bowing. Because both filaments are not equally deformed potentially indicates the thick wire filament was not incandescent at the time of impact and was hot because of it’s proximity to the incandescent filament. There is not enough evidence at this time to determine the status of the hazard lights at the time of impact. (Baker) Therefore, one cannot state to a reasonable degree of scientific probability that the hazard lights were on or not on at the time of the collision.

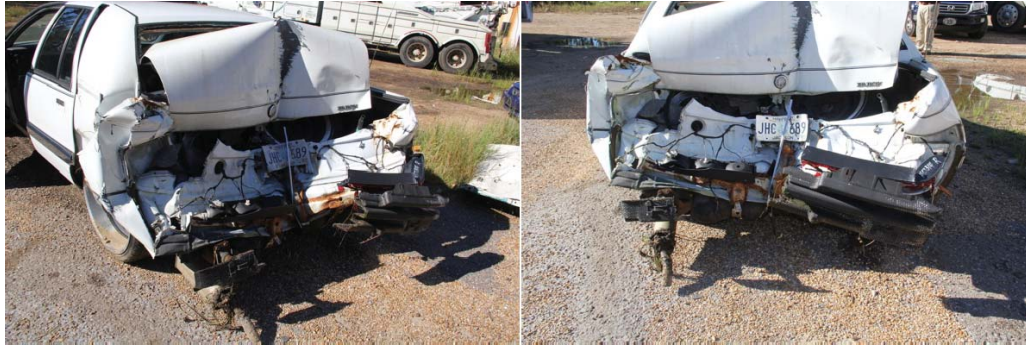
Photograph: Crush damage

The vehicle sustained damage to the rear, including damage to the rear bumper, trunk, and driver/passenger side quarter panels. Crush measurements were taken at the inspection to determine approximate closing speed. Based on these measurements, the Freightliner was offset to the driver’s side slightly.

The closing speed at impact between the two vehicles was estimated by using crush stiffness coefficients and crush measurements applicable to the 1995 Buick Roadmaster. The coefficients were applied to the measurements of the approximate width and depth of the damage compared to published vehicle dimensions.

Based on the analysis of the damage, the closing speed at impact was calculated to be approximately 45 miles per hour. (Robinson) (Tumbas & Smith) If the Freightliner was travelling between 52-58 miles per hour, that would put the Buick's speed at impact between 7-13 miles per hour. This is inconsistent with Mr. Williams response to interrogatories that they were travelling approximately 58 miles per hour moments before impact. This is also consistent with McCon's medical records where he stated they were traveling no more than 10 miles per hour.

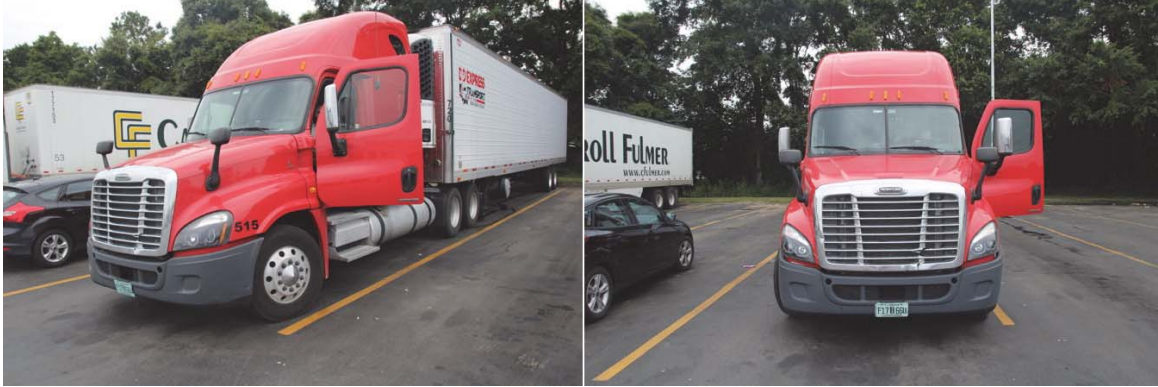
Photograph: 2008 Freightliner at time of download

On 15 June 2016, the 2008 Freightliner Cascadia was downloaded and photographed. The VIN was documented as 1FUJGLCK38LY72335 at this time with Florida tag F1766U. The tractor and trailer were both documented as D&D express with tractor number 515. At the time of this inspection, the majority of the damage to the tractor had been repaired, as the tractor had been put back in service. The front grille appeared to be the same as at the time of the accident. The ECM download was the only activity conducted, no other inspection of the tractor or trailer was done at this time.
